Philadelphia Quartz Plant, Baltimore, MD

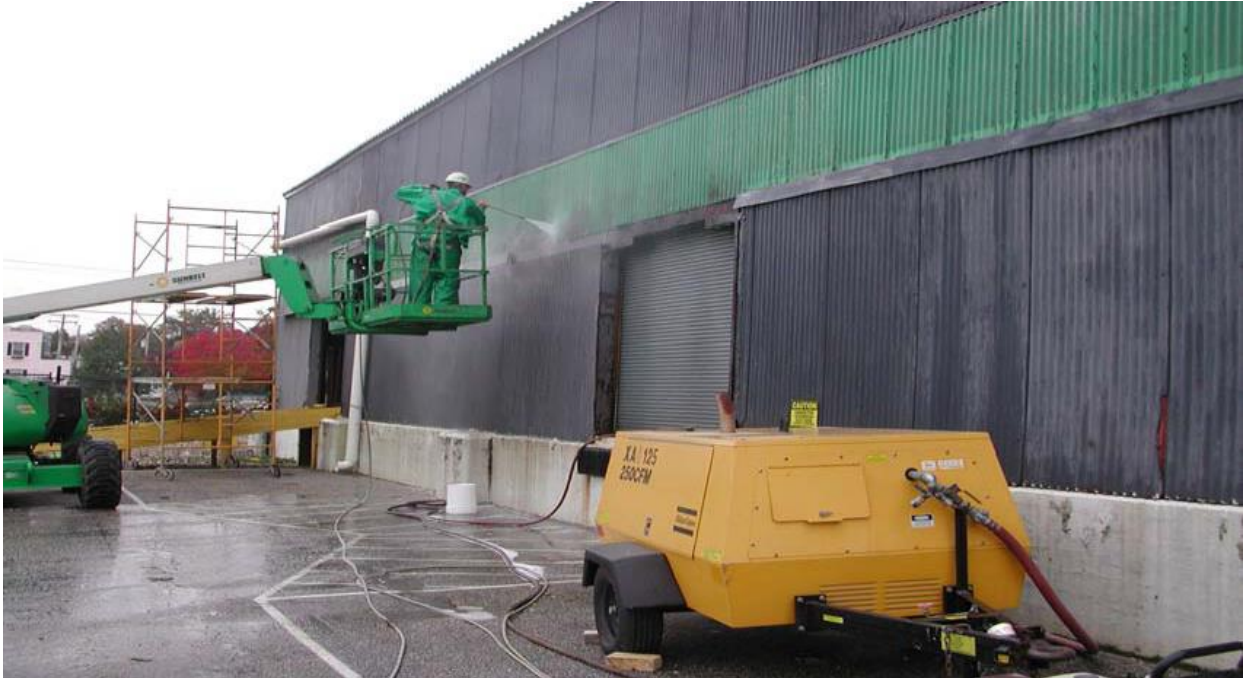
The Challenge: The Baltimore Philadelphia Quartz Plant was in need of repairs to the roof and the exterior transite (asbestos) and lead based paint covered walls. The interior support steel was covered with flaking lead based paint. The exterior walls had holes that required patching and the exterior was covered with green mold.
