## Riverbay Corp. Coop City, N.Y.

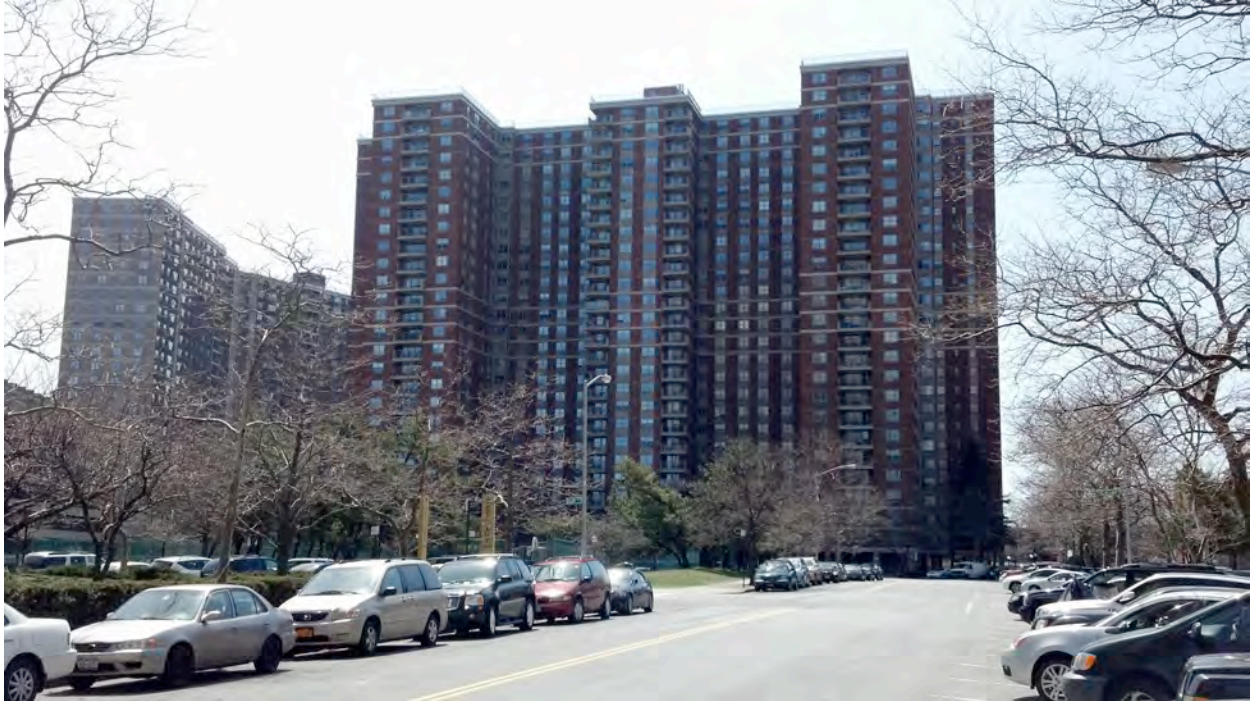
**The Challenge:** The pipe insulation in this Tri-Core building was in very bad shape. There were many areas in disrepair. Mold was apparent on the outside of the pipe insulation and was creating a hazardous condition for the residents.

**The Solution:** Riverbay Corp. chose the FiberTech F-50MR Mold Resistant Primer and F-51MR Mold Resistant Sealer Coat for all of the pipe insulation coating repairs. All of the insulation was first saturated with Benefect botanical disinfectant and allowed to dry. All of the insulation that was loose was reinforced with our butyl seam tape. The entire basement pipe insulation was then coated with 1 coat of the FiberTech F50MR Mold Resistant Primer followed by two coats of Fibertech F-51MR Mold Resistant Sealer Coat.
