United Methodist Church, Litchfield, CT

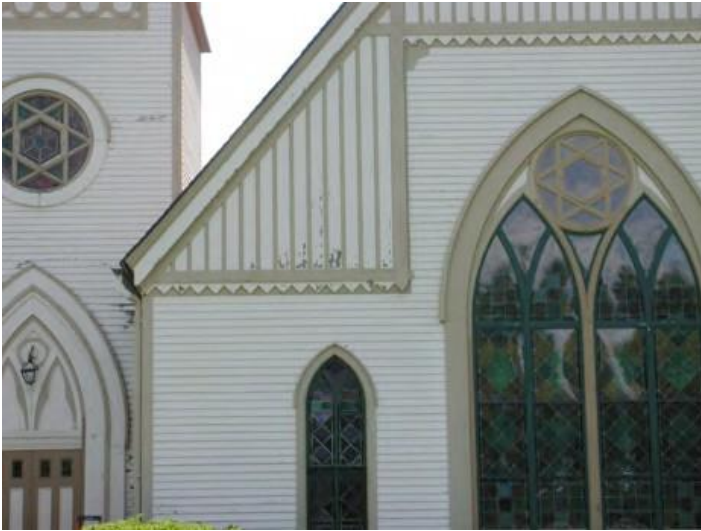
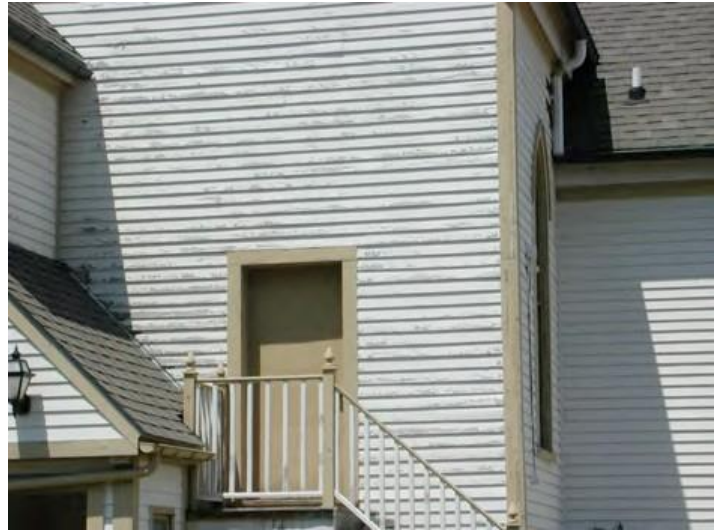
The Challenge: This historic Litchfield Church had loose and peeling paint on the entire exterior of the building. The congregation wanted a coating system that would stabilize the exterior surfaces of the building, would provide a waterproof membrane, and would last for at least 20 years.

The Solution: The ECI FiberTech Encasement System was chosen. The contractor applied one coat of the F-50 Penetrating Stabilizer Primer followed by two coats of the F-51 Sealer Coat. This provided the church with a waterproof coating system that will last for at least 20 years.
