Union Ice Arena, Union, NJ

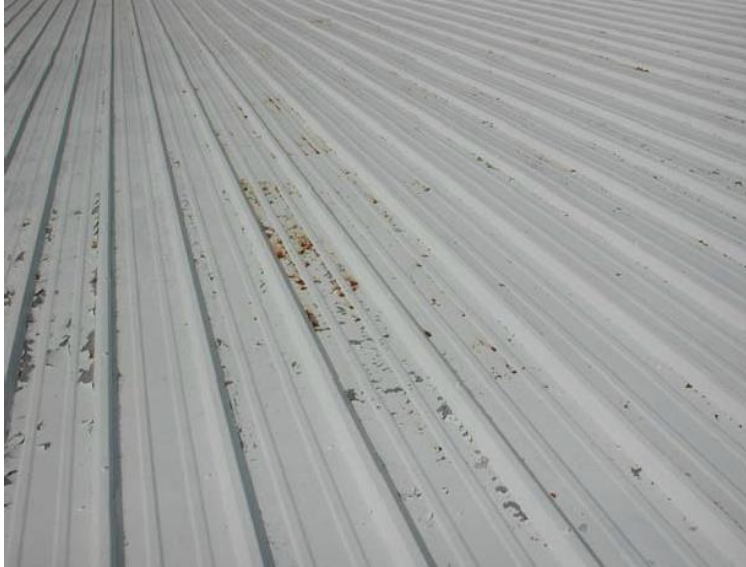
The Challenge: The Union Ice Arena's 60,000 square foot roof coating system was failing and there was evidence of rusting on the metal substrate. The owner wanted a coating system that could be applied over the failed existing system and would provide a long-lasting, flexible, rust inhibiting, and solar-reflective waterproofing system.

The Solution: The ECI Encasement System was chosen. ECI first power washed the roof, with ECI's biodegradable cleaner, which removed all dirt and mold from the roof surface. All areas of exposed rust were then wire brushed and spot primed with the F-50MS. ECI then applied its encasement system consisting of one coat of the FiberTech F-50MS Rust Inhibiting Stabilizer Primer and two coats of the FiberTech F-51 Sealer Coat. This system provided the owner with rust protection and a waterproof jacket on the roof surface. ECI was able to provide the owner a ten year warranty for this application.
