## AMB Warehouse, Southern New Jersey

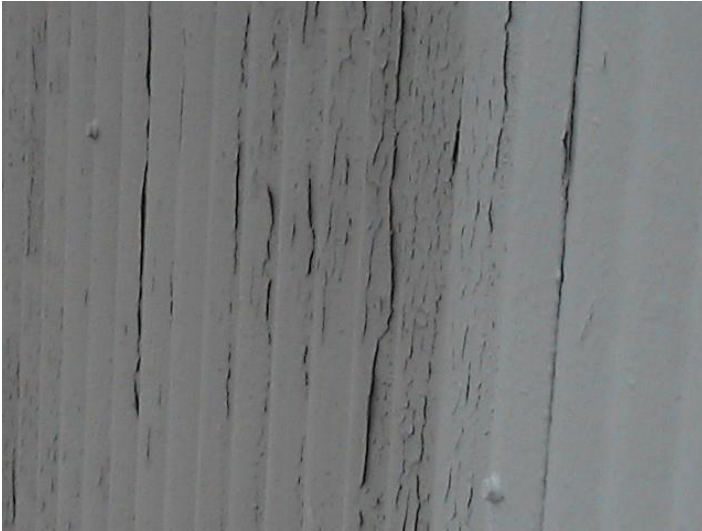
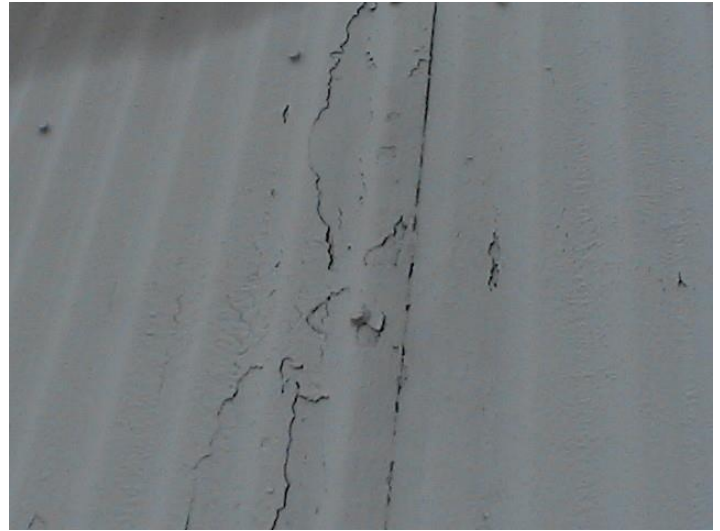
**The Challenge:** This warehouse building in South Jersey had deteriorated paint over asbestos transite corrugated panels on the exterior and similar paint conditions on the interior. The owner wanted the entire building to be coated with an encasement system that would waterproof the exterior of the building and provide long term protection of the asbestos panels. Over 100,000 square feet of surface area needed to be coated.
