Central Warehouse, Rikers Island, NYC DOC

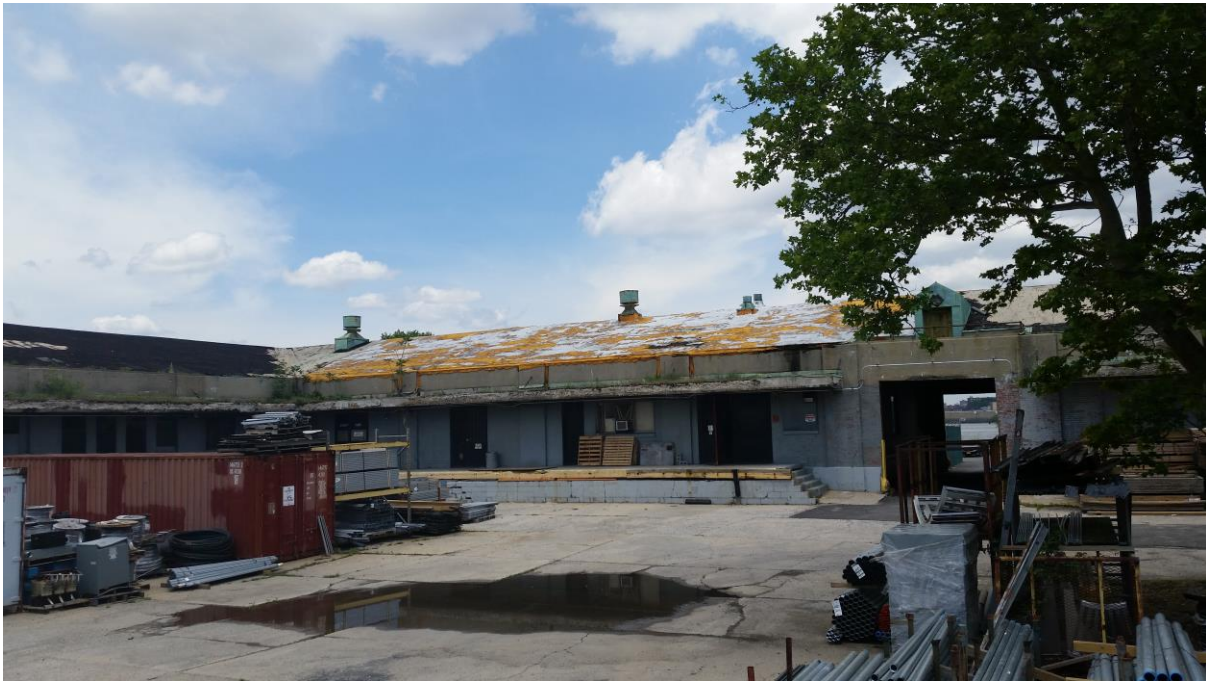
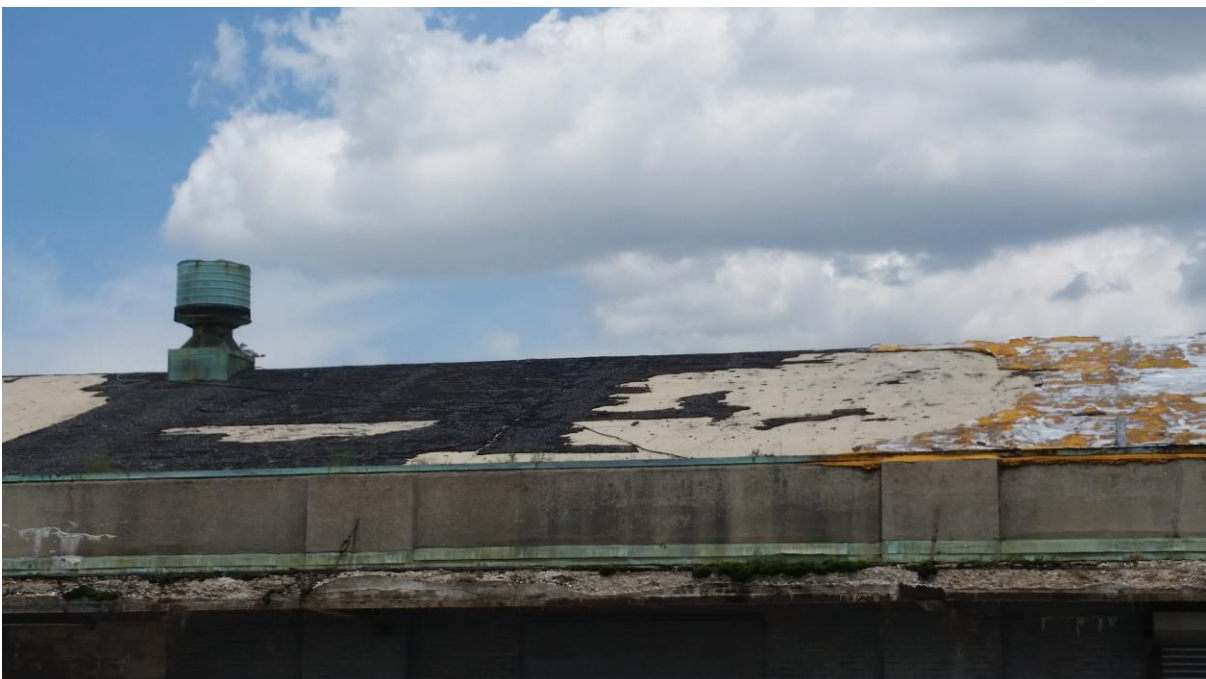
The Challenge: The head of facilities at Rikers Island was having serious problems with roof leaks. Water was coming into the warehouse structures in the Central Warehouse Operation Division where all of the plumbing and hardware parts were stored. They had reviewed several different options and wanted a system that could be installed with little to no disturbance to the employees in the warehouse. They were concerned with using other traditional roofing as there had been failures within months of previous installations.
