Garnerville Elementary School, N.Y.

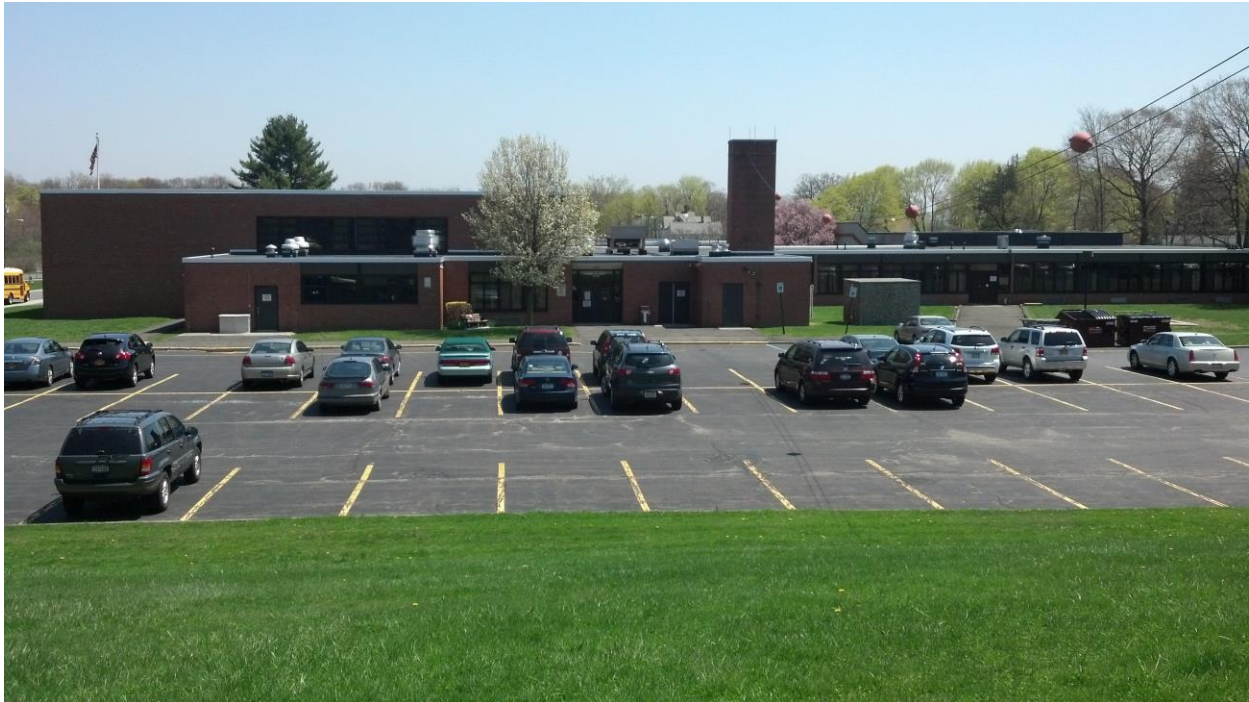
The Challenge: The roof system was compromised and the Tectum decking was completely saturated. This on-going problem caused the growth of mold on the underside of the decking in several areas of the school building including hallways and the school library. The mold had to be removed and the school wanted to eliminate the re-growth of the mold.

The Solution: The decking was cleaned and a new roof was installed over the Tectum deck. ECI cleaned and disinfected the entire mold infected areas inside the school. We then applied one coat of our FiberTech F-50MR Mold Resistant primer followed by two coats of our FiberTech F-51MR Mold Resistant Sealer Coat. This provided the school with the solution they were looking for.
