Ocean County Municipal Authority, NJ

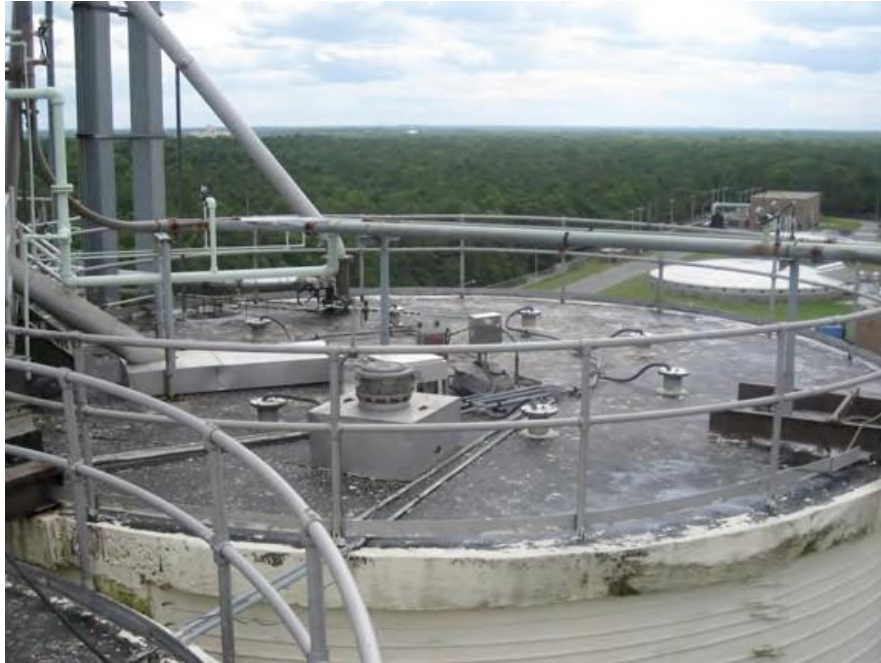
The Challenge: The client had a failing coating system on each of their silos and wanted to replace it. The surface below the coating system was a bitumen membrane over concrete. They wanted to waterproof the cylindrical surface, which needed to be walkable for routine maintenance.
