Riverbay Corp., Coop City, Bronx, N.Y.

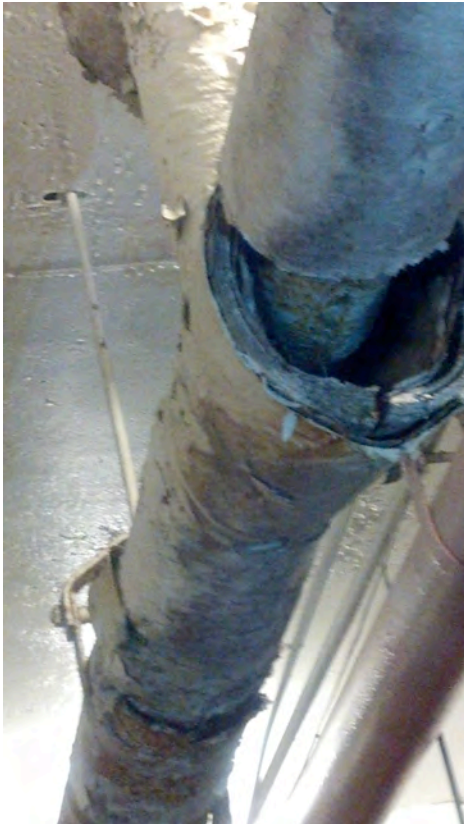
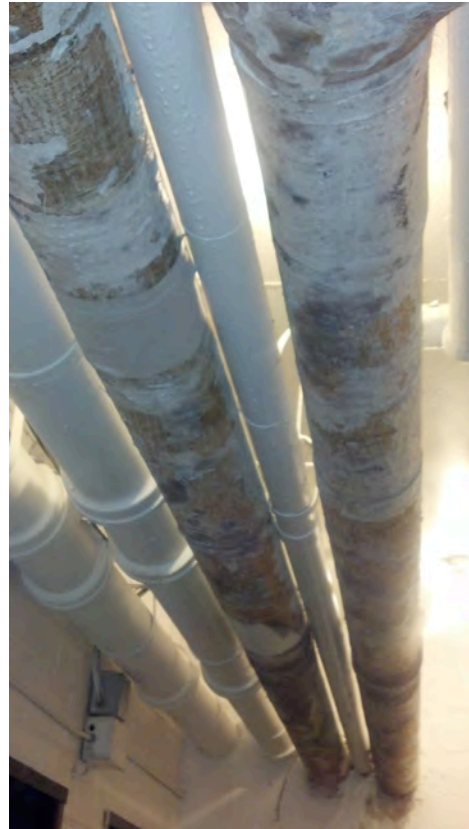
The Challenge: The pipe insulation in the basement area of the building was full of mold and was in disrepair. The ownership wanted to make the area safe for residents and wanted the mold problem eliminated and the insulation repaired and wanted a coating that would prevent the future growth of mold.

The Solution: The ECI FiberTech encasement system was chosen. The insulation was first completely saturated in our Benefect botanical disinfectant and then allowed to dry. All of the loose and separated areas of the insulation were repaired using our butyl seam tape. The FiberTech F-50MR Mold Resistant Primer was then applied, followed by two coats of our FiberTech F-51MR Mold Resistant Sealer Coat.
