Riverbay Corp. Coop City, N.Y.

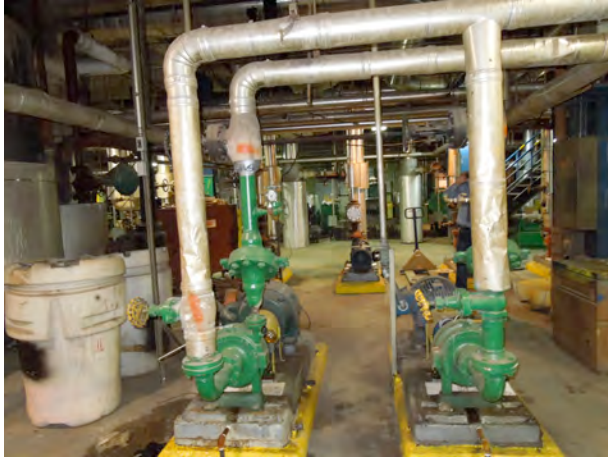
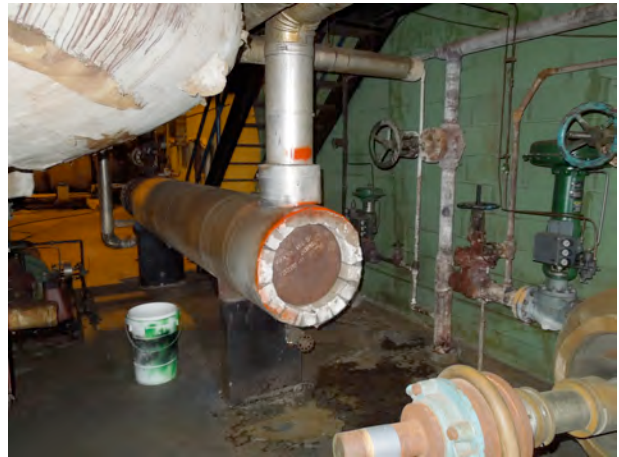
The Challenge: The powerhouse had several areas where the asbestos block insulation had become exposed. There were also areas where the cloth wrap covering the asbestos insulation was also in disrepair.
